# VEHICLE INSPECTION REPORT

**VN16PKC**

## Dennis Elite 6

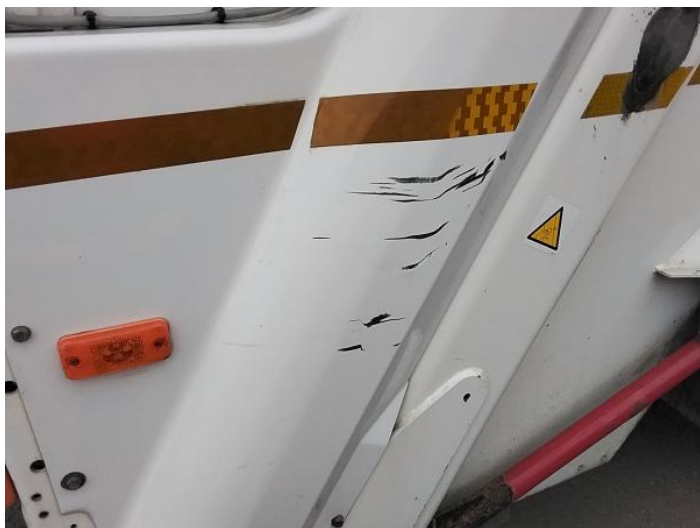
1: Qtr Panel Moulding os  
Scratched (Painted)  
Over 25mm Thru Paint

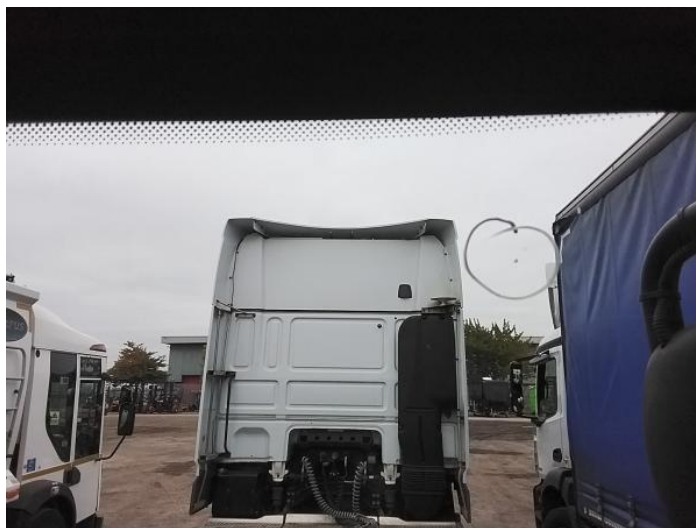
2: Screen Front  
Chipped  
UpTo 10mm

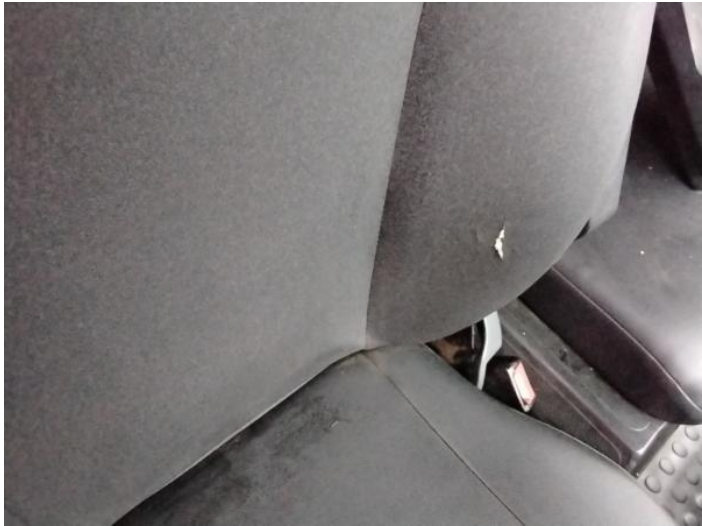
3: Seat Back Cover osf  
Torn  
Over 3mm
